All CYC boat owners

Advanced Electrical: Galvanic Isolator Case Study

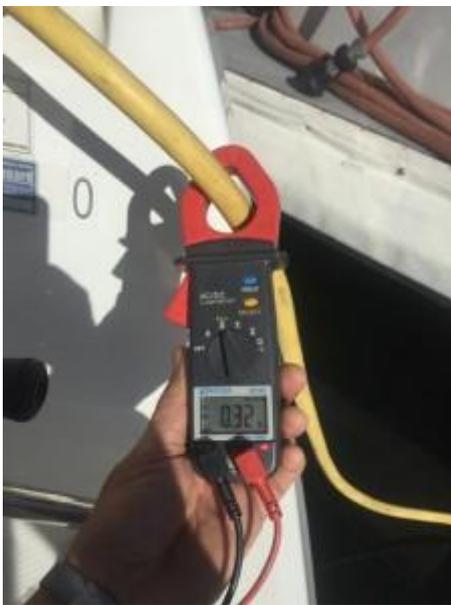
Before the galvanic isolator was installed:

But if we plugged in his shore power cord, his *hull potential* changed by about 200 millivolts. Aha, problem found, but people want to point to some AC problem, since this is coming from the AC shore power cord. Nay. [Galvanic corrosion](#) and stray current corrosion are caused by DC currents.

In fact, I could measure half an Amp of DC current by putting my Amp clamp, on the *DC* setting, around his shore power cord.

A galvanic isolator blocks low level DC currents from traveling down the AC safety ground.

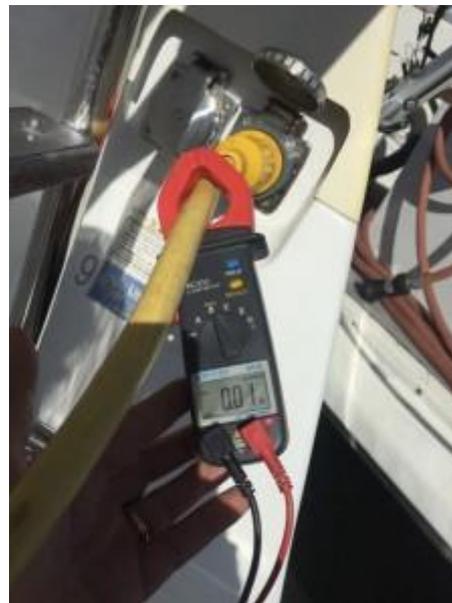
and AFTER

Voila! But two days before I'd read .5 Amps, instead of .3 Amps. What changed? I don't know, but .3 is still bad.
